Isuna 10000-20000T Battery Prohibited Discharge and Battery Prohibited Charging Alarm Solution

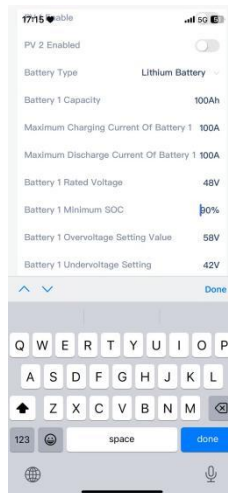
Inverter alarm: Battery 1 or 2 is prohibited from discharging

1. The current battery capacity is greater than 10% and discharge cannot continue.

Solution: Enter the ESS LINK APP, select "Me", select "My Device", select "Device Information", select "Three Points in the Upper Right Corner", select "Parameter ", select "Battery Settings", and select the minimum SOC.

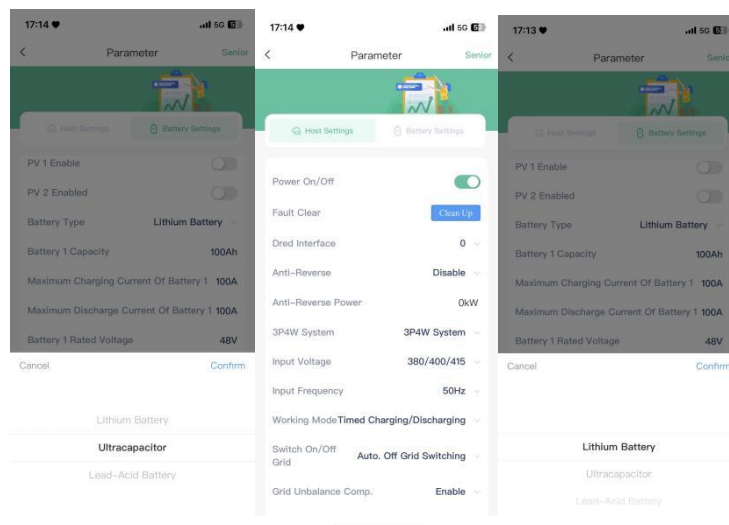
Inverter alarm: Battery 1 or 2 prohibited from charging

2. When the battery capacity is less than or equal to 10% and only connected to the power grid and battery, and not connected to the photovoltaic system, and charge cannot continue.

Solution: Change the battery type to Ultra capacitor, wait for 30 seconds for the inverter to clear the fault, then change the battery type back to lithium battery, and charge the battery.

Specific operation: Enter ESS LINK - select "Me", select "My Device", select "Device Information", select "Three Points in the Upper Right Corner", select "Parameter", select "Battery Settings", select "Battery type" - Change to Ultra capacitor confirmation, select "Host settings", select "Fault clearing", select "Clear", select "Confirm" - Wait for 30 seconds, select "Battery Settings", select "Battery type", select "Lithium battery confirmation"-and then battery can be charged.
